Japanese Knotweed Control 2024

Craftsbury VT Conservation Commission

2024 Craftsbury Conservation Commission work on the Watershed Grant from VT Fish and Wildlife

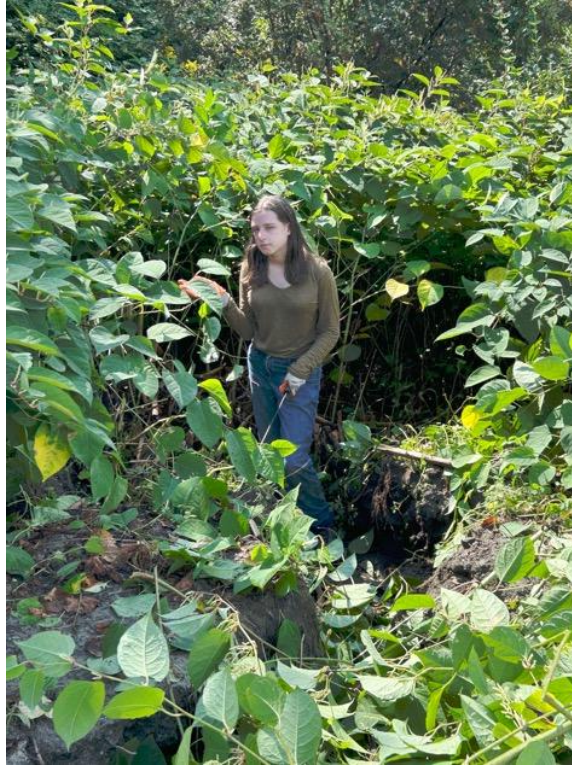
Before 2024 work.

JK (Japanese Knotweed) on **8/30/23** after an earlier cut. The gully from TH19 is knee deep where this Sterling College student is standing. All summer of 2024 volunteers cut and dug JK to stay ahead of cur construction of willow dams, installation of the drying rack, removal of rocks, and placement of fascines.

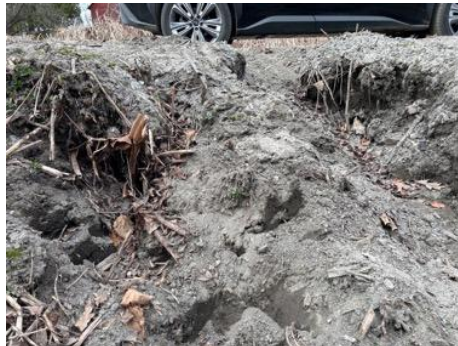
WILLOW CHECK DAMS 4/15/24

Sterling College students, on *All College Service Day*, built willow check dams to keep erosion from the road from flowing into the stream.

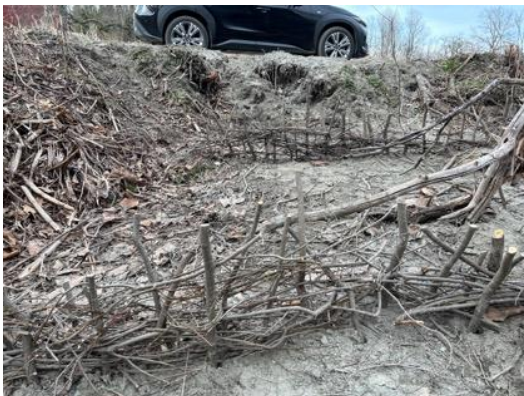
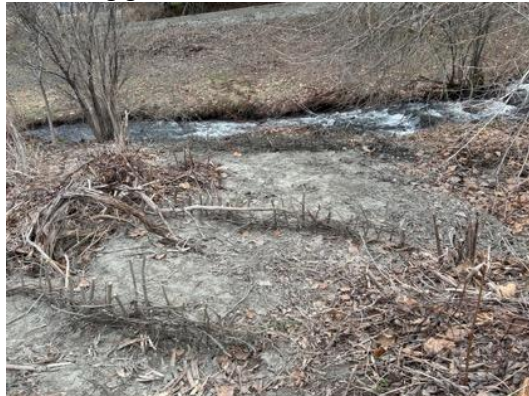
TH19 roadside bank showing gullies

In the afternoon, Elinor Osborn and Farley Brown met with Ben Matthews of DEC who gave advice on laying erosion fabric: "Lay only on level areas, and not over stream bank. Can also lay on steep slope if upper edge is put in a trench and buried with soil dug from trench and big stones so no water can run under the fabric. The Town could put ditch rock under the fall from each culvert. The Town might be able to cover the steep slope with ditch rock if it is a minimum of 1' vertical for 1 1/2' horizontal. Town also could put ditch rock in the gullies from TH19."

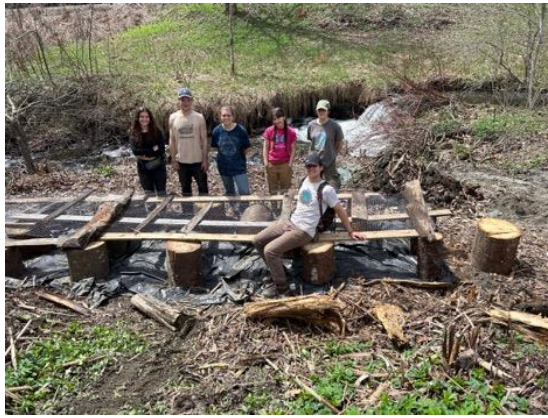
DRYING RACK 5/3/24

On Sterling College's *All College Work Day*, seven students and Farley Brown, their instructor, cut and dug JK in the area where a drying rack would be placed. It was made of chicken wire nailed on old lumber placed on wood blocks. Roots were cut off the JK stalks and placed here to dry until no longer viable. Little Hosmer Pond is at left.

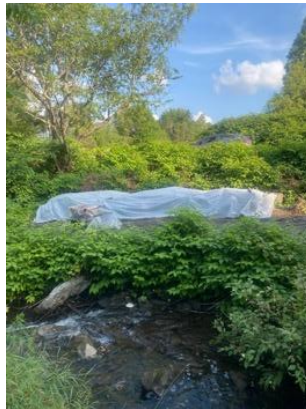
8/1 We discovered that covering the roots on the drying rack with white plastic cooked and dried them faster

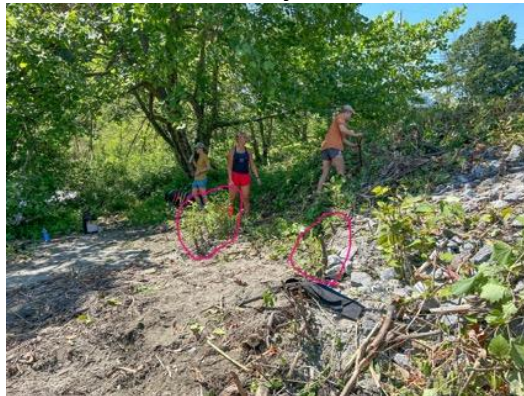
U23 work day 6/25/24

U23 (under the age of 23) athletes from the Craftsbury Outdoor Center spent the afternoon digging JK. This photo shows the sprouting willow check dams with road erosion built up to about a foot behind them. The town road crew had filled the gullies with ditch rock which was not stopping erosion and had JK growing up between rocks. We could not dig or pull JK, the roots were so constricted by the rock. So we decided to remove the rock.

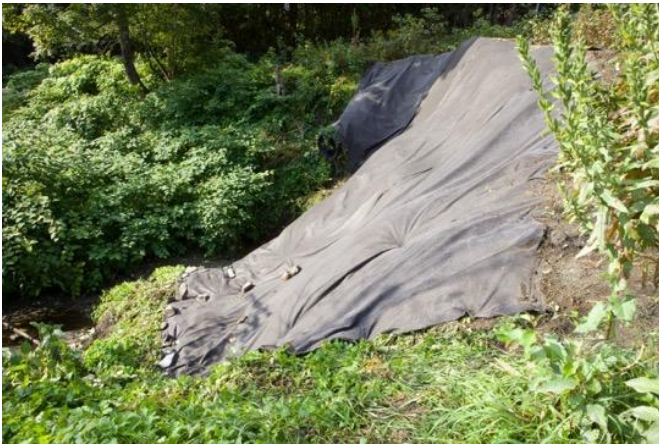
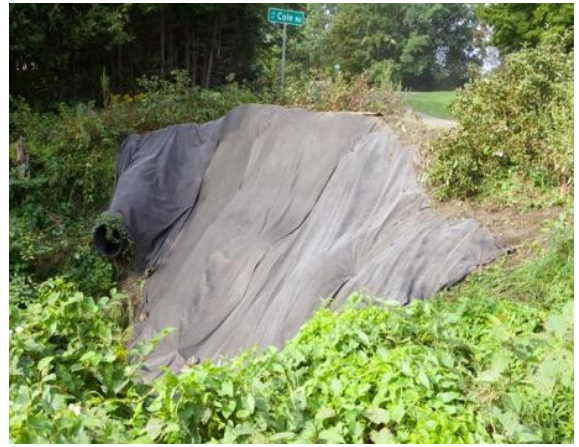
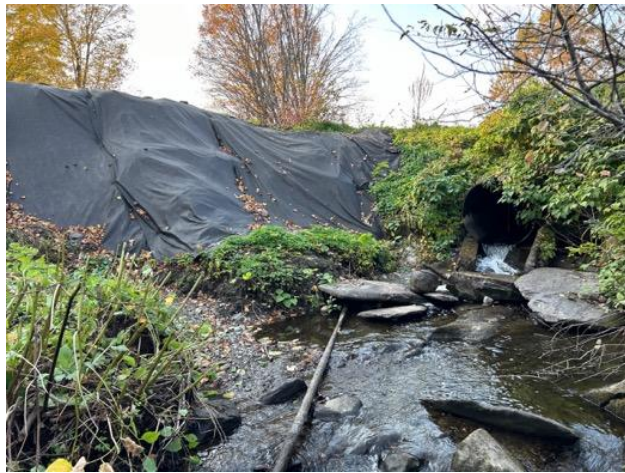
STEEP SLOPE EROSION FABRIC 8/26/24

Two intrepid mountain goat volunteers laid the fabric on this slope (same slope, three views) and stapled it down. They secured the fabric at the top using Ben Matthews' (of DEC) directions.

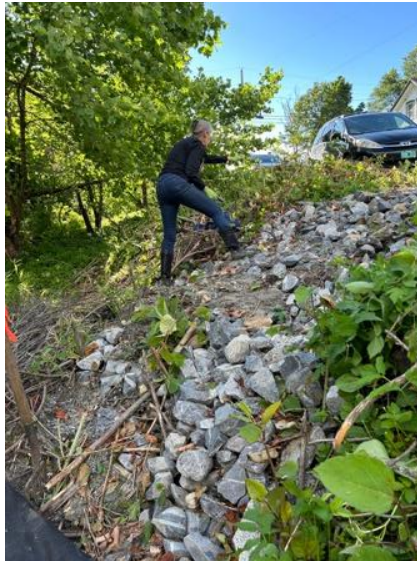
REMOVING THE DITCH ROCK FILL

6/27/24 JK has been cut from the ditch rock fill in order to remove the rock from the gullies off TH19.

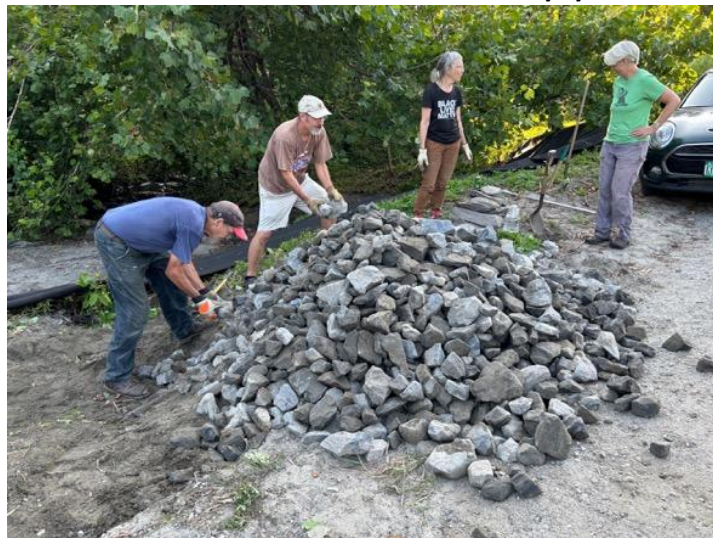
Rocks removed from TH19 gullies for town to take back.

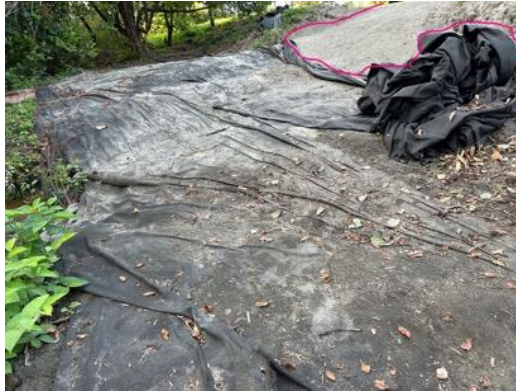
9/17 The area outlined in red shows where rocks were removed and the gully filled. The whole road bank with its many gullies had the same treatment.

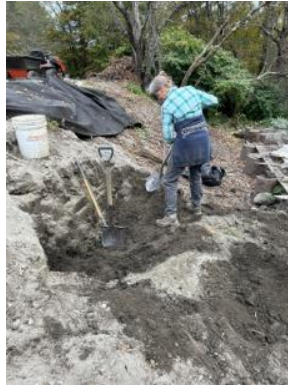
Volunteers dug down 4' to remove JK from the embankment.

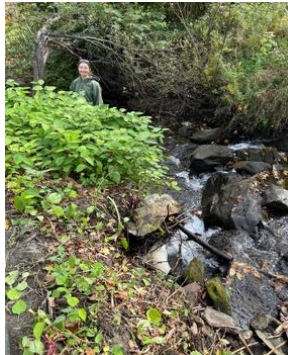
A student has cut JK on part of the 4' high stream bank with more to cut. Digging JK roots will be done there next spring in 2025 when we can have green fascines ready to immediately stake into the stream bank to hold it.

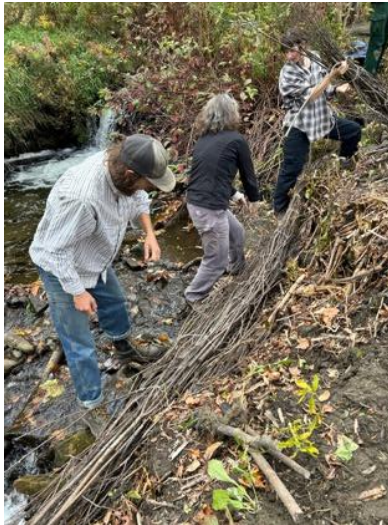
Farley Brown's Watershed Class staked non-growing fascines on the 4' high stream bank to give more stabilization to the bank over the winter.

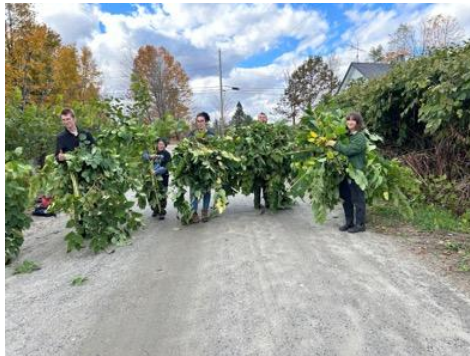
Carrying stalks to the stalk pile from more cutting this day. After the roots were cut off to place on the drying rack, stalks were removed to a drying pile on the ground since we found they do not re-root as long as there is no evidence of root growth on them.

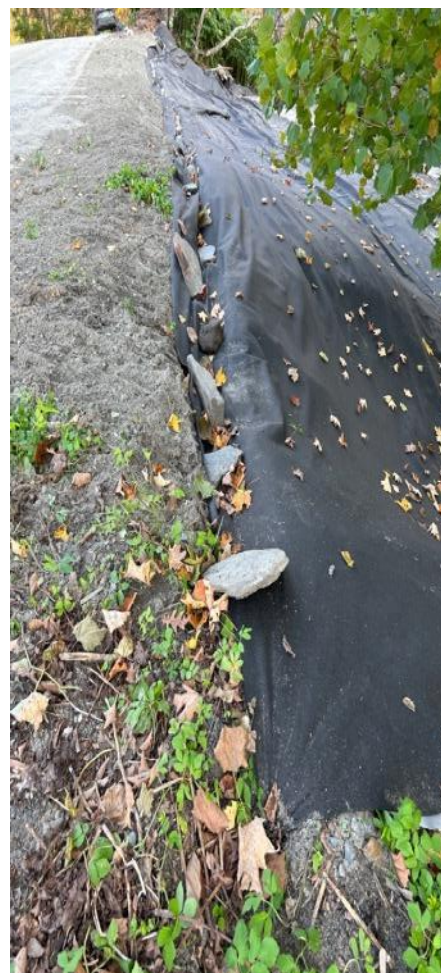
Rocks to help hold fabric at top of TH19 slope

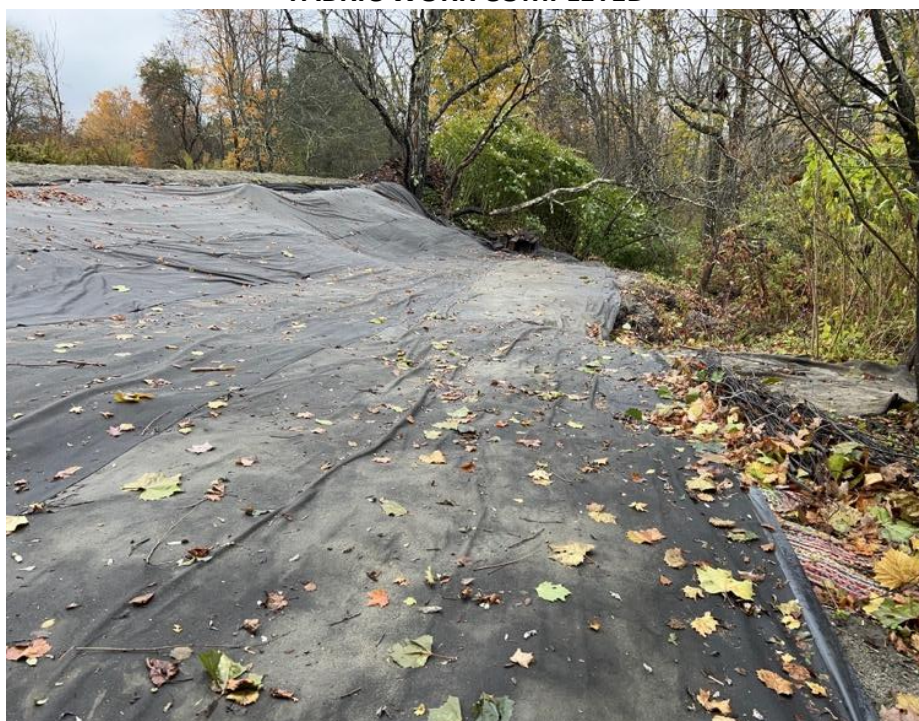
From sycamore tree on west end looking east. Outlet stream is on right

So far the fabric has been preventing road erosion from going down to the stream.

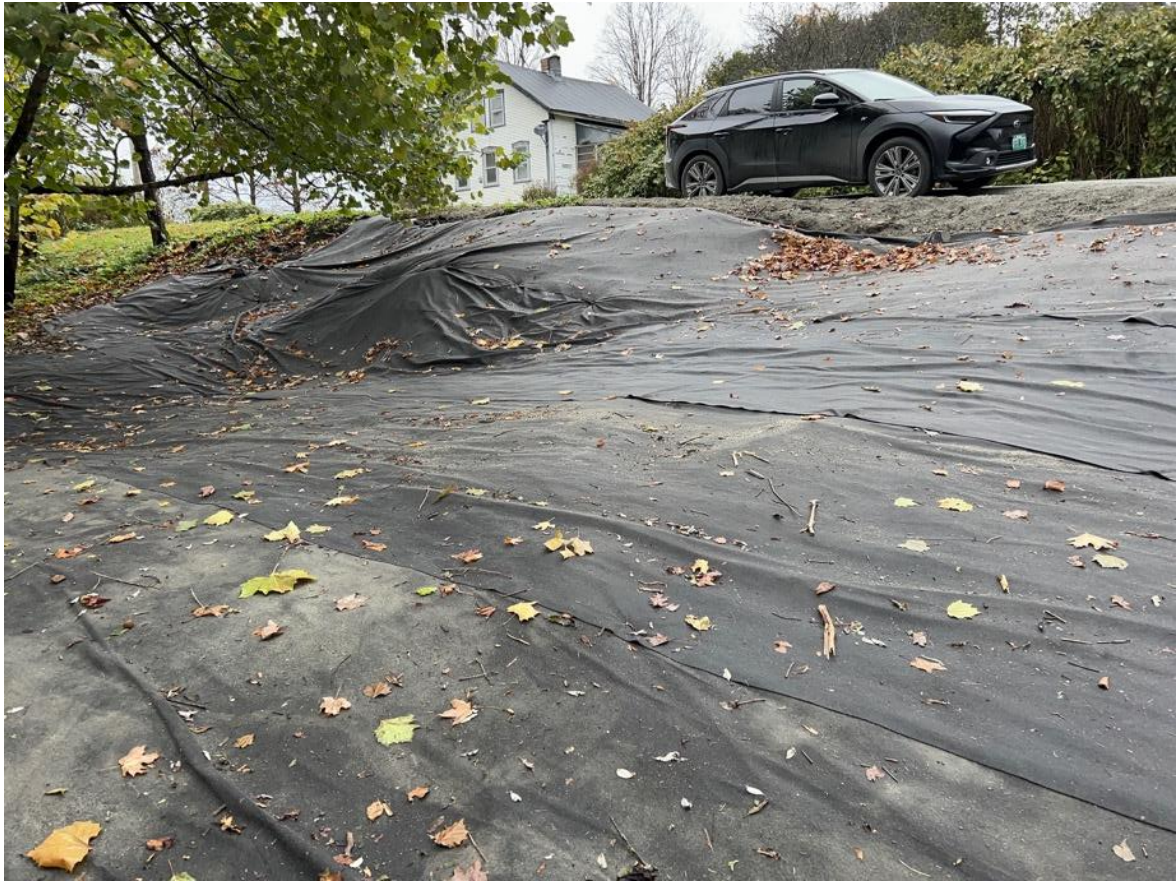
Looking from east to west. Stream is on left.
